# **PROPOSED EREBUS MEMORIAL, DOVE MYER ROBINSON PARK, PARNELL, AUCKLAND: ARCHAEOLOGICAL ASSESSMENT OF EFFECTS**

Prepared for Ministry for Culture and Heritage and The Building Intelligence Group

July 2020 (updated from December 2019)

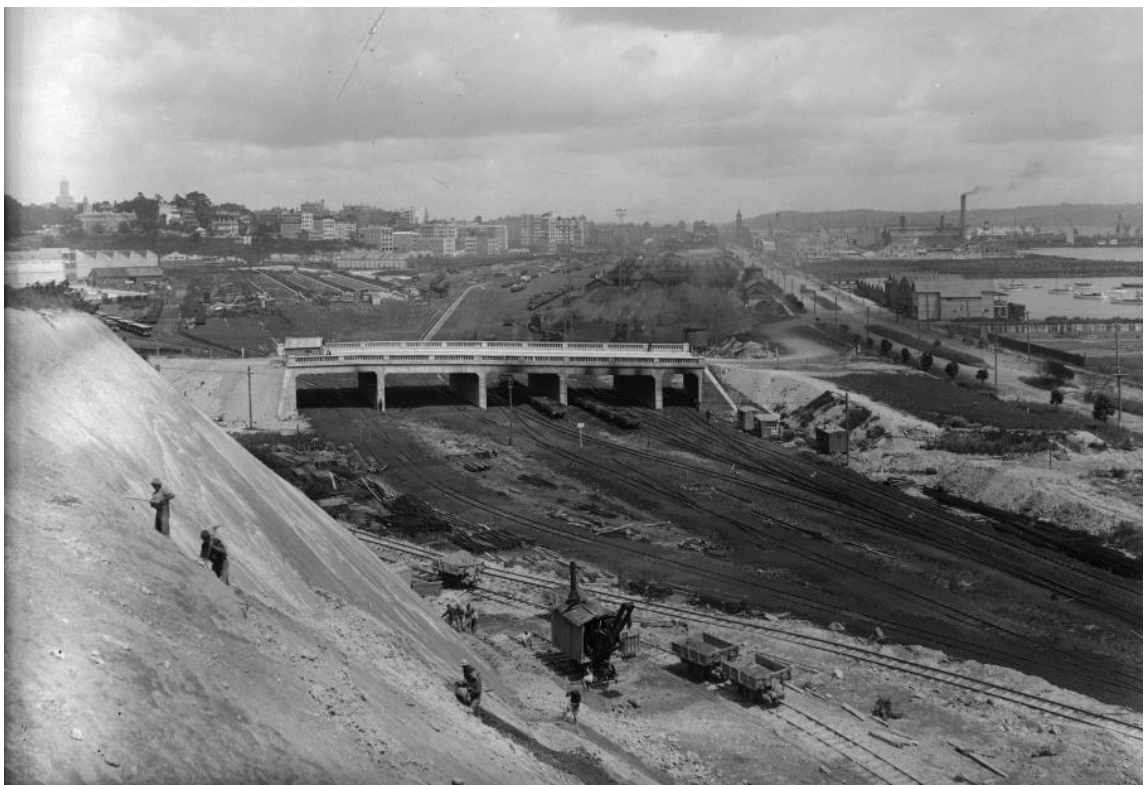
During the late 1910s to mid-1920s, the northern end of Campbells Point was cut down to enable the construction of Tamaki Drive, the connection of Gladstone Road to The Strand and the construction of the Britomart to Westfield rail line (Salmond Reed 2011). Figure 17 shows the original coast alignment and the extent of Campbells Point, which was subsequently removed during the 1920s. Figure 18 and Figure 19 show the earthworks being undertaken.

**Figure 19. 1927 photograph 'showing me breaking down Campbell's Point for the new railway outlet'. Henry Winkelmann photograph. Auckland Libraries Heritage Images ref. 1-W1858**

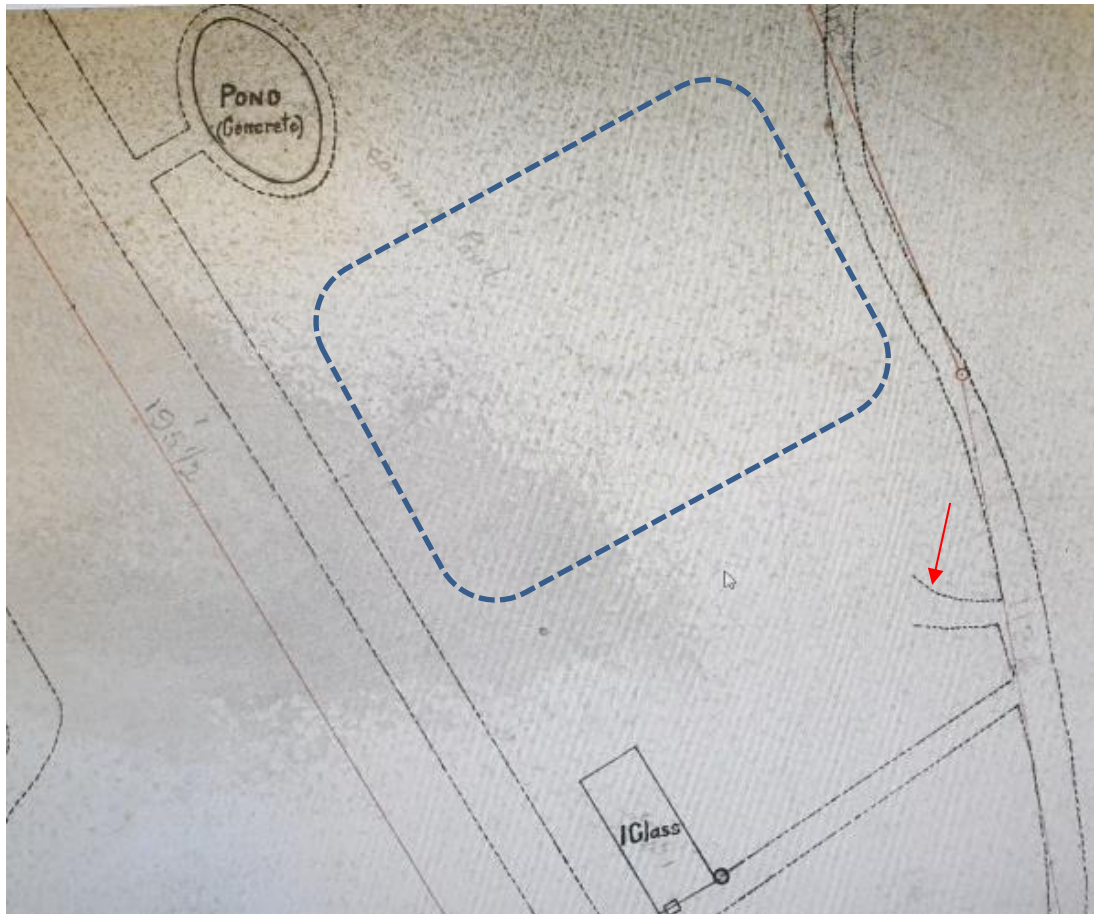
**Figure 25. Detail of Parnell Field Sheet No. 34, sheet 1 (1916) showing a pond, glasshouse and possible additional track alignment (marked with arrow). The general current project area is outlined. Source: Auckland Council Archives ref. ACC 015 4058-34a**

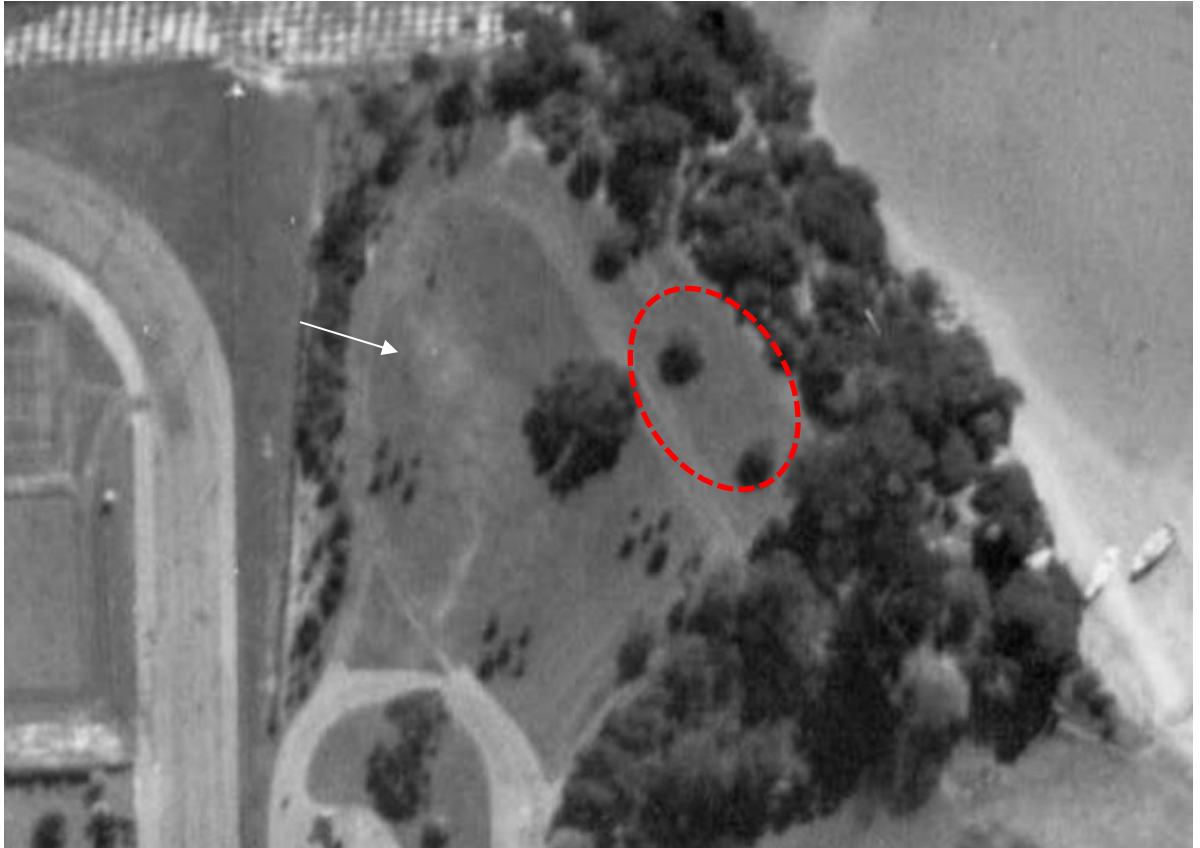
An early aerial photograph from 1940 shows that Kilbryde had long since been demolished (Figure 26). Many of the pathway alignments that are shown on the 1916 plan (Figure 24) are evident, but appear to have grown over or not been formalised. By 1950, very little had changed, although the pathway alignments appear clearly and may have been sealed by this time (Figure 27).

**Figure 26. Detail of 1940 aerial photograph. The site of the former Kilbryde house is marked with a white arrow and the general current project area is circled in red. Aerial source: Retrolens ref. SN146-64-13**

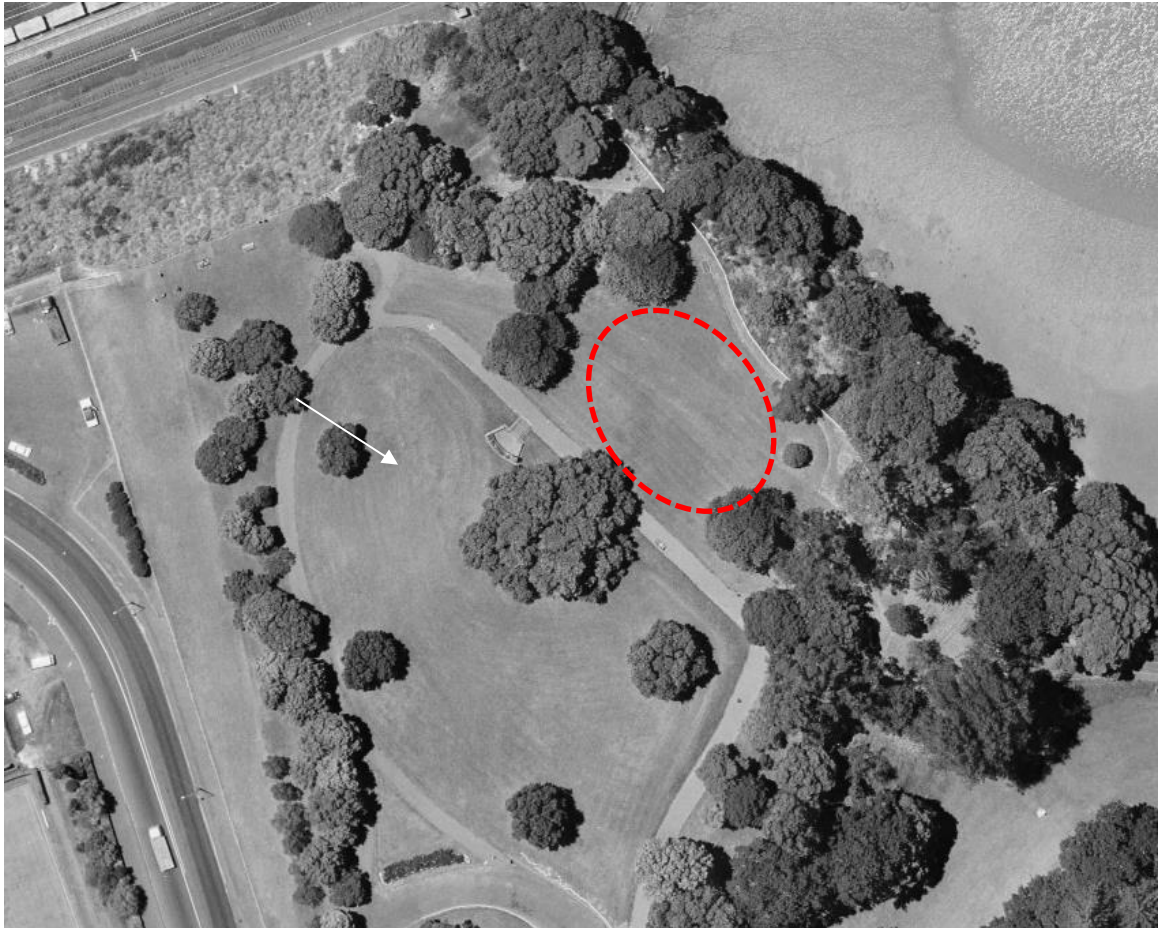
**Figure 27. Detail of 1950 aerial photograph. The site of the former Kilbryde house is marked with a white arrow and the general current project area is circled in red. Aerial source: Retrolens ref. SN583-1917-31**

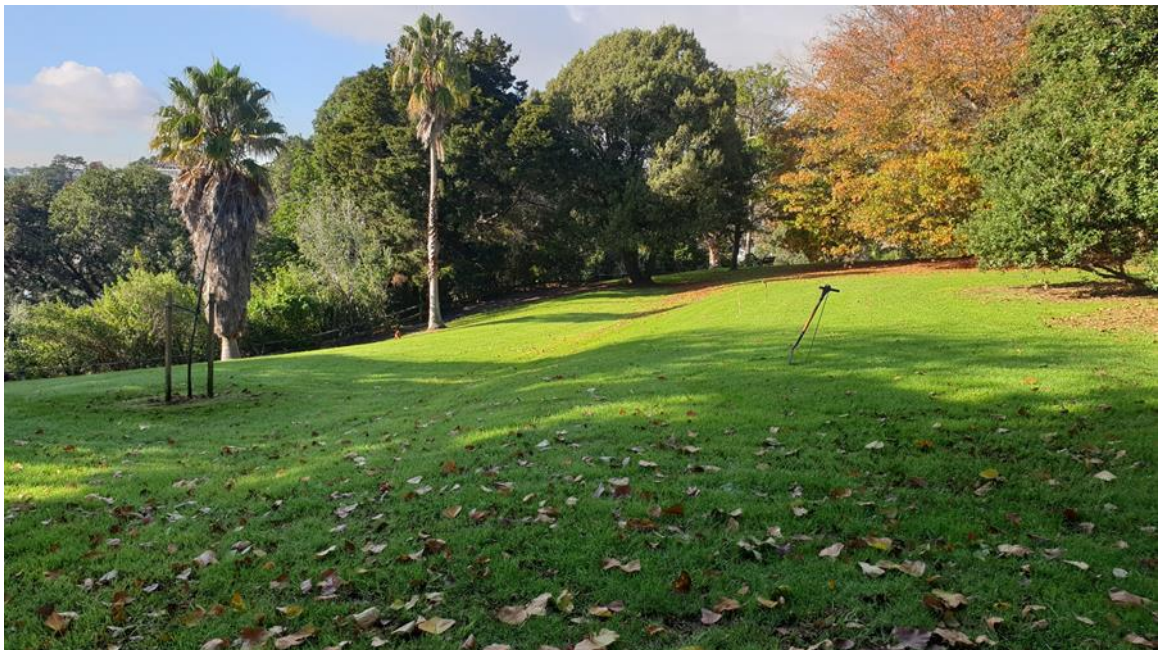
The original site assessment identified what appeared to be two broad lateral grassed terraces located on the east-facing slope where the memorial is proposed to be located (Figure 28). The terraces are located to the north-east of the site of the former Kilbryde House and were thought likely to be associated with the late 19th or early 20th century landscaping works undertaken by Campbell (Figure 29).

**Figure 28. View looking over the proposed memorial site showing the broad landscaped terraces**

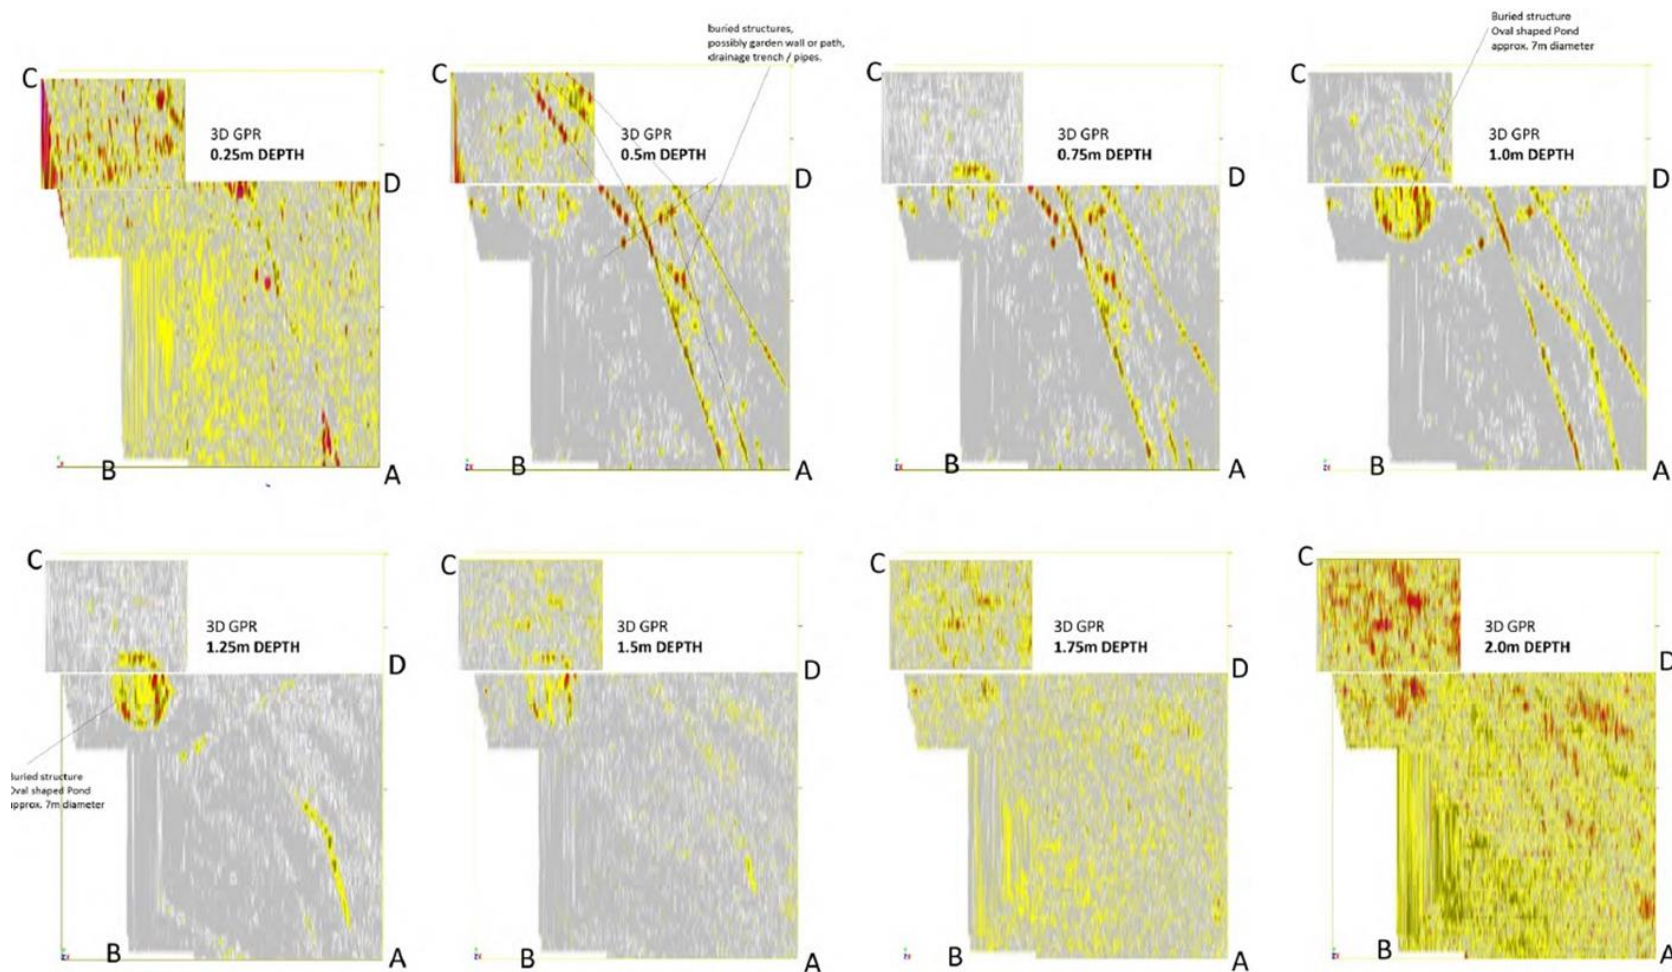
Figure 33. 3D GPR Survey Results of proposed memorial site. Source: Watson 2019

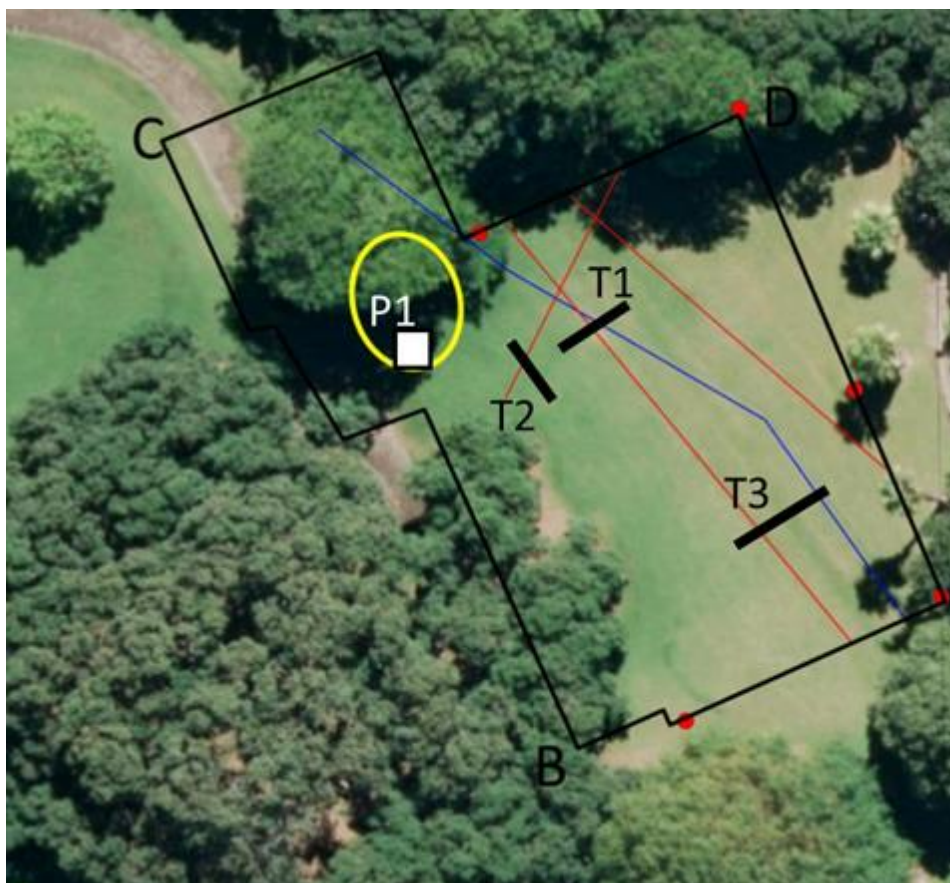
**Figure 34. Aerial showing the location of test pits ('P#') and test trenches ('T#')**

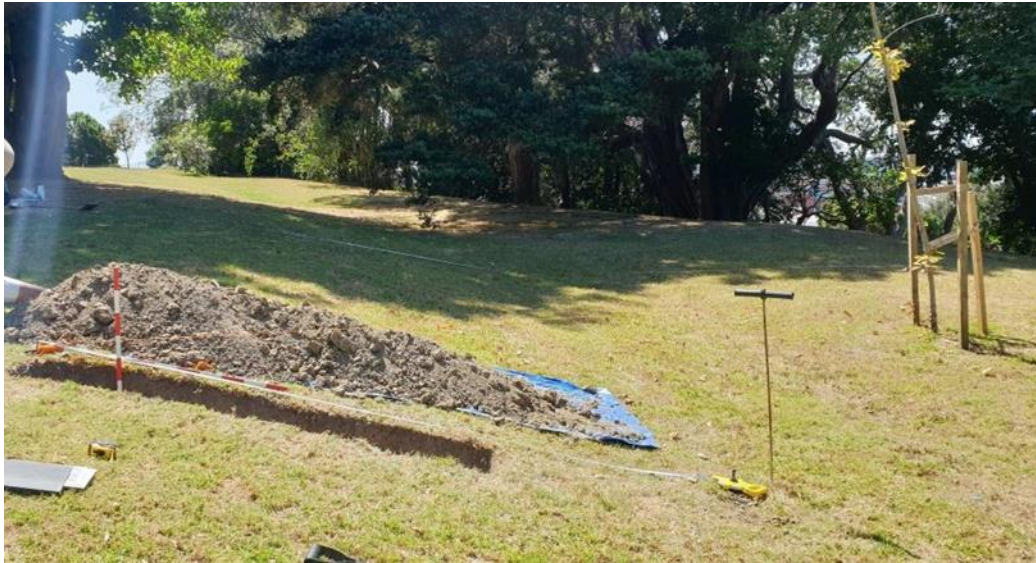
The investigations also illustrated the extent of previous modifications on the site, with thick layers of compacted pale grey mixed silty clay exposed both on the top 'terrace' area and on the back scarp of the former track/road alignment. The soil profile of Trench 1 (Figure 35–Figure 38) showed that the back scarp of the former road alignment had been built up with a mixed pale grey silty clay, likely during its construction but also potentially later during landscaping works for Kilbryde or during works for the development of the park. The fill was largely sterile with the exception of window glass fragments from the

**Figure 36. View looking north over Trench 1**

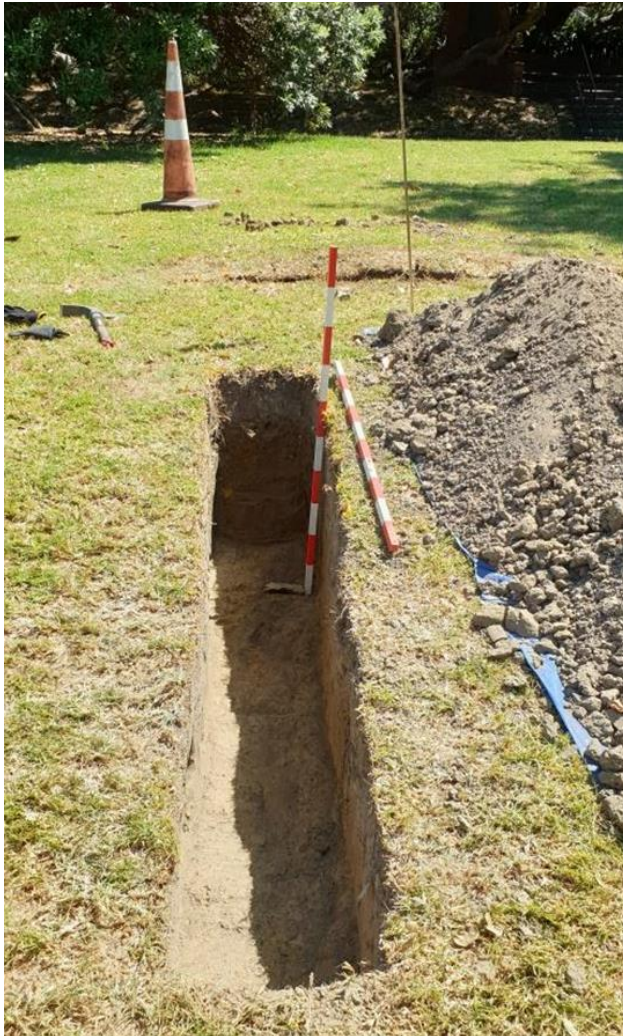
**Figure 37. View looking west over Trench 1**

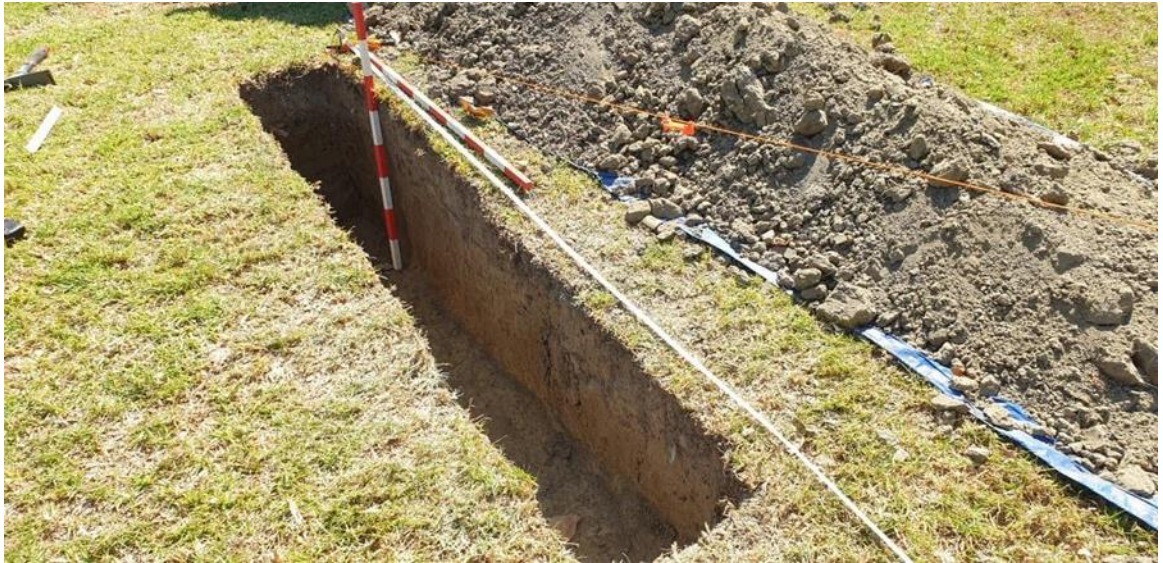
Figure 38. Photo looking west showing soil profile of Trench 1

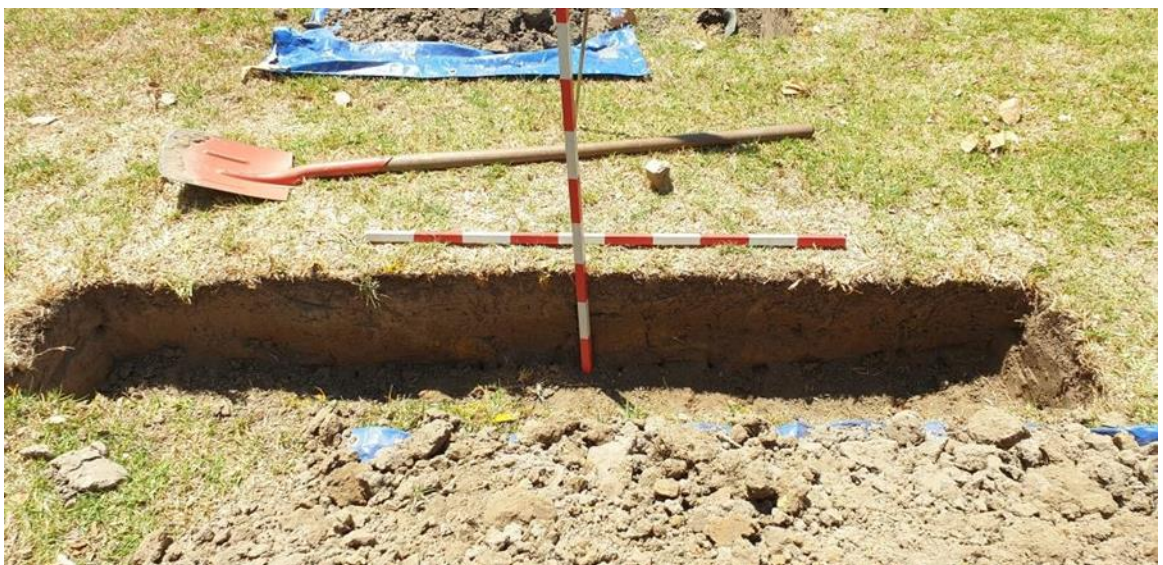
upper levels. Trench 2 was excavated to a depth of only 30cm as ground conditions prevented deeper excavation by hand. Probing was undertaken at 10cm intervals along the base of the trench; however, no subsurface archaeological remains were able to be identified.

Figure 40. View looking east showing the eastern soil profile of Trench 2

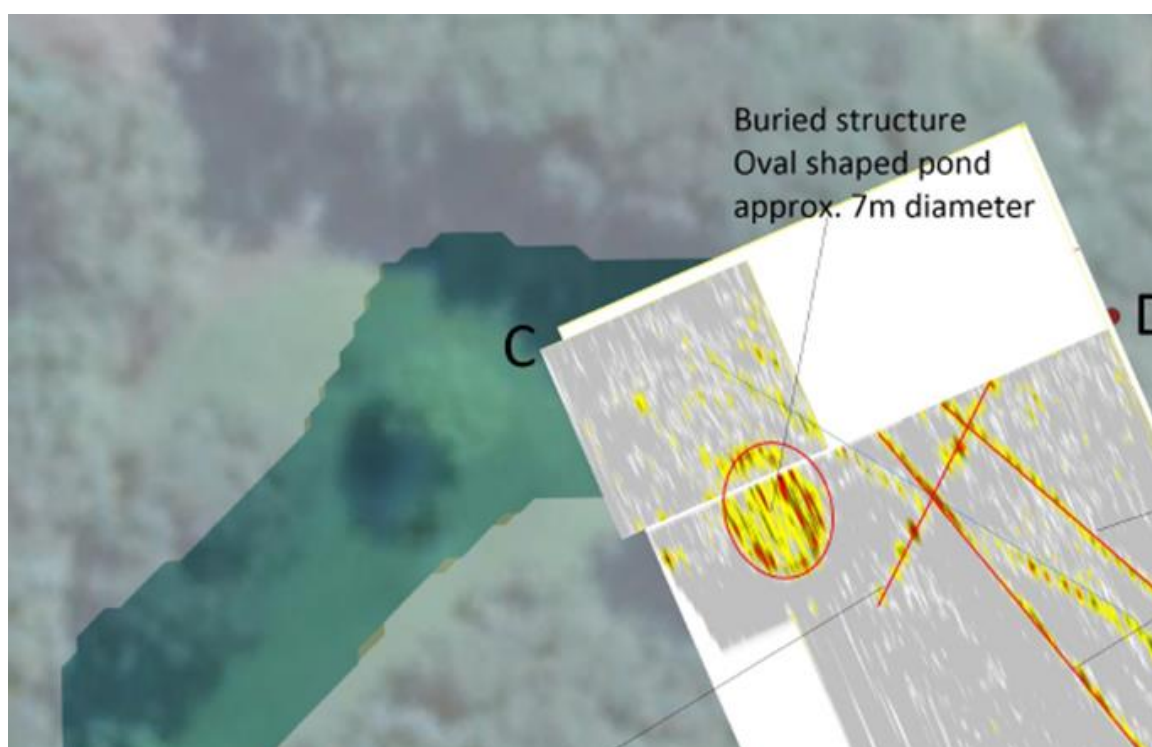
**Figure 41. Detail of GPR results overlaid onto an aerial showing the location of the pond/fountain.**  
Source: Watson 2019

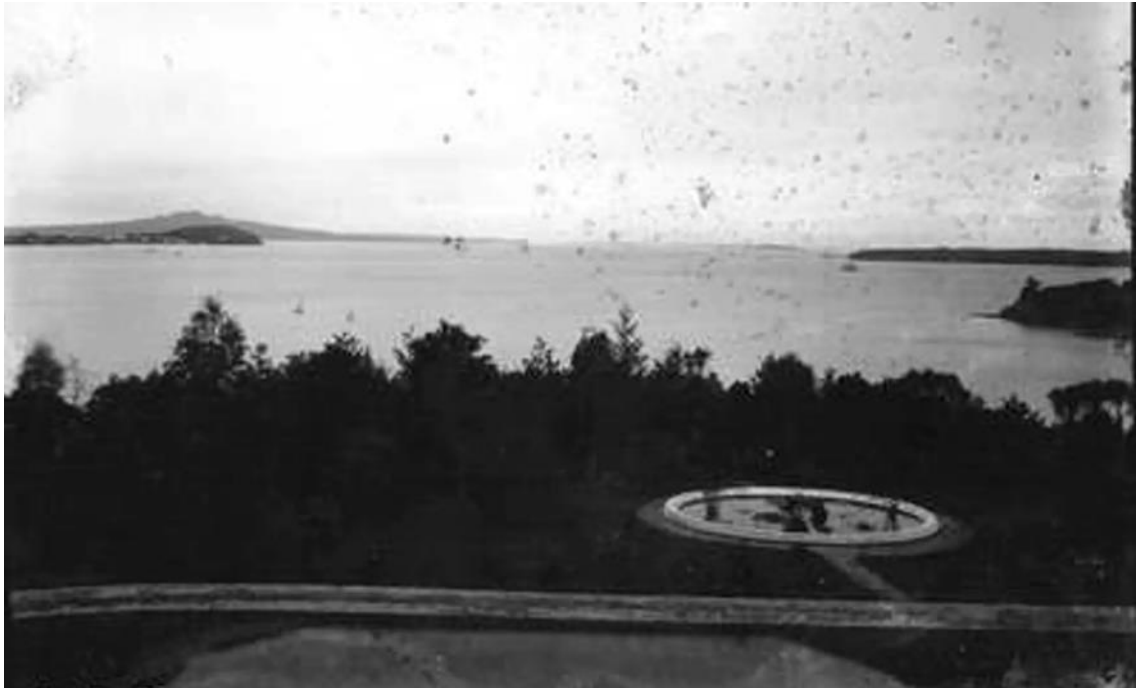
The subsurface remains of Campbell's pond/fountain were clearly identified during the geophysical survey (Figure 41). The pond is shown on a number of photographs dating to the late 19th and early 20th centuries and was a significant feature and focal point within the Campbell garden (Figure 42–Figure 44).

**Figure 42. Auckland Harbour from Kilbryde. Arthur Ninnis Breckon photograph taken c. early 1900s overlooking the pond/fountain and pathway. Source: Auckland Museum ref. PH-NEG-A547**

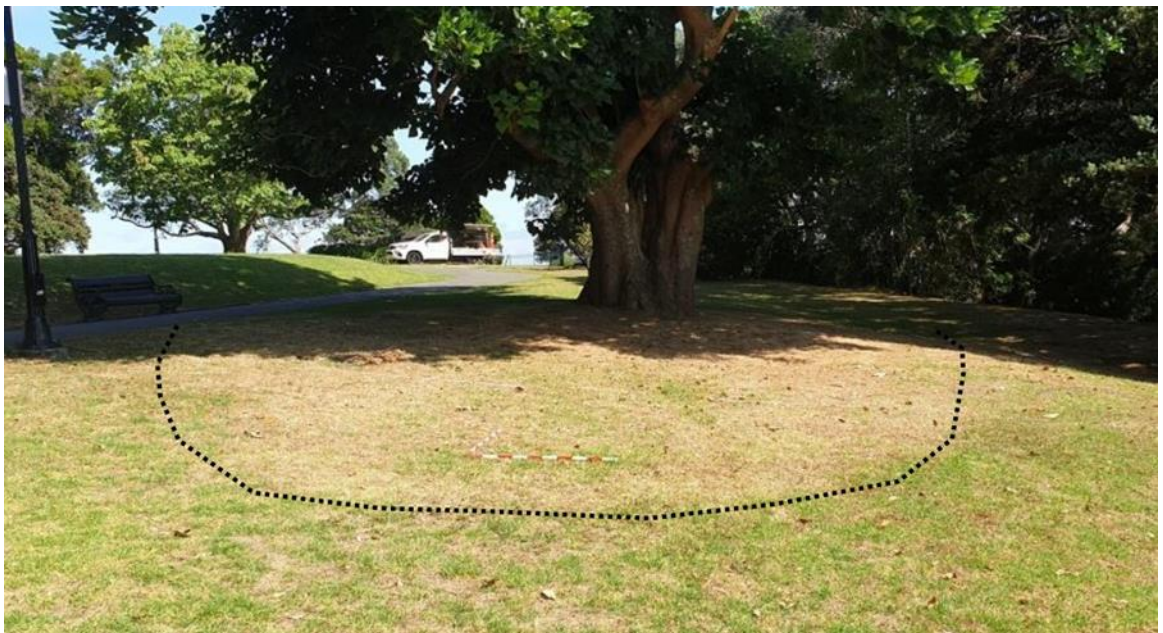
Prior to the investigations and due to particularly dry weather over the summer period, it was noted that the subsurface footprint of the pond appeared to be visible as a patch of very dry grass beneath the Flame tree (Figure 45). This area was mapped onto the site plan. A single test pit of 0.5m<sup>2</sup> was excavated into the grass close to the southern edge of the pond/fountain site outside of the root structure of the flame tree.

**Figure 45.** View looking north-west over the location of the pond. The dry grass appears to correlate with the subsurface remains of the pond (shown with black line)

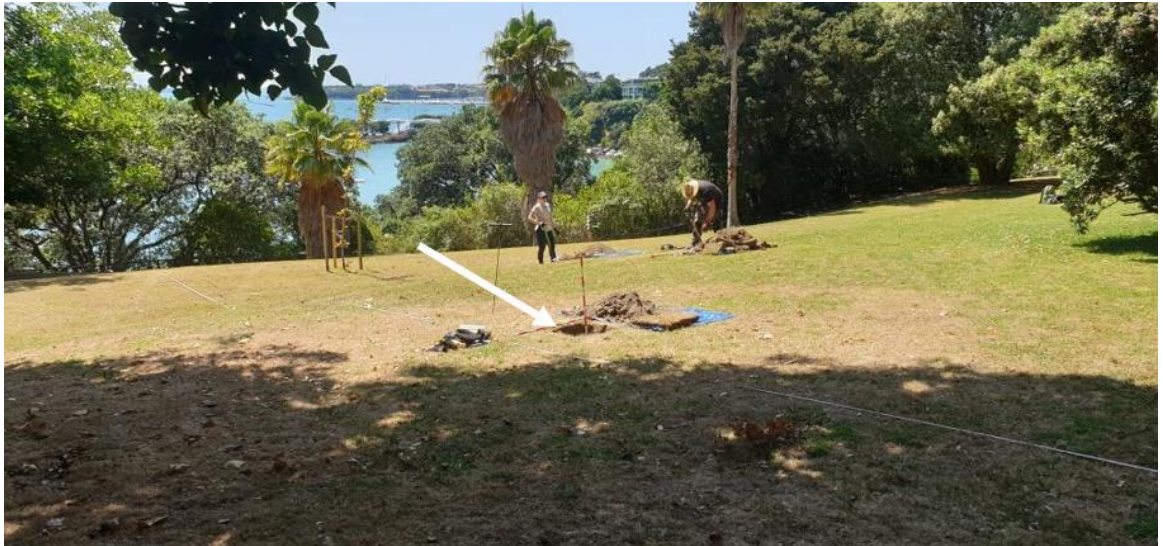
In situ concrete remains of the pond/fountain were identified at a depth of 30-34cm below the existing ground surface (Figure 46–Figure 48). The concrete remains were overlain with a densely compacted, pale grey mixed silty clay soil containing loose fragments of concrete, glass, glazed terracotta drainage pipe, non-diagnostic animal bone and a small unidentified pressed metal item (Figure 49).

**Figure 46. View looking north-east over the location of test pit 1 (marked with arrow), located within the original footprint of the pond/fountain**

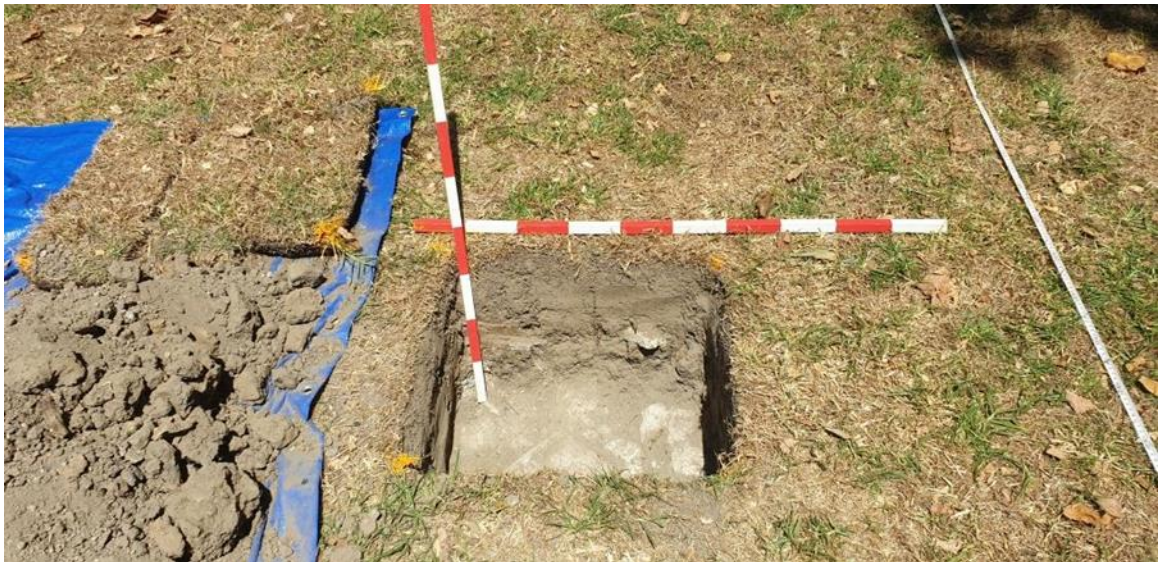
**Figure 47. Test pit 1 showing the concrete remains of the pond/fountain at the base of the pit**

The current proposed works are unlikely to affect the subsurface remains of the pond (Bray 2019, pers. comm.) as works within this area comprise the removal of topsoil to a depth of only c.200mm and then the installation of fill and subsequent development of the new pathway (Figure 67). These works have been designed to avoid impacts on the identified extent/depth of the remaining pond foundations which are located at 300mm+ beneath the existing ground surface. The proposed drainage alignment has also been re-routed to avoid impacts on the subsurface remains of the pond (Figure 67). The installation of a tap within this area will take into account the location of the pond foundations and ensure that they area avoided.

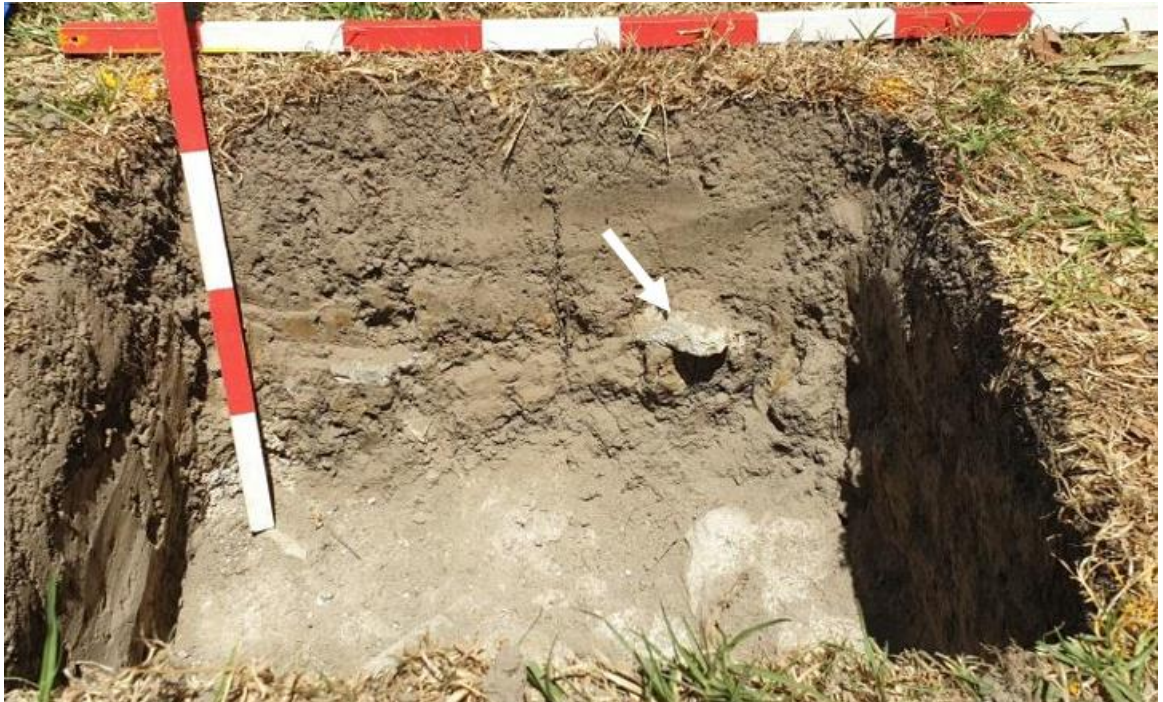
**Figure 48.** Close up of test pit 1. The in situ remains of the pond/fountain base are exposed at the base of the pit. Fragments of concrete were also identified within the overlying fill (marked with arrow)

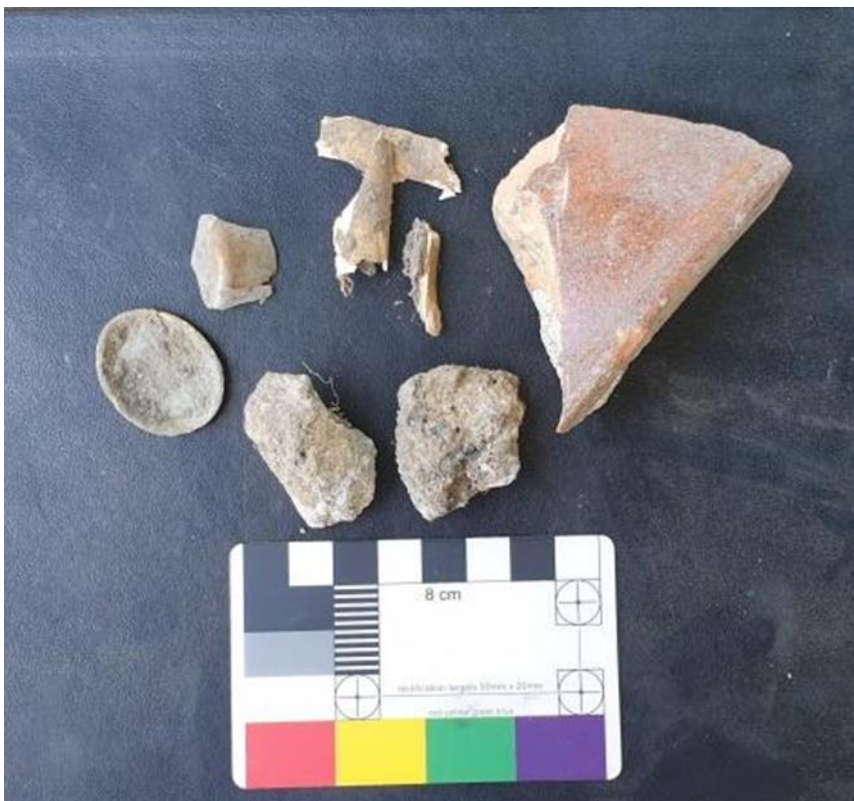
**Figure 49.** Material recovered from the fill overlying the base of the pond/fountain

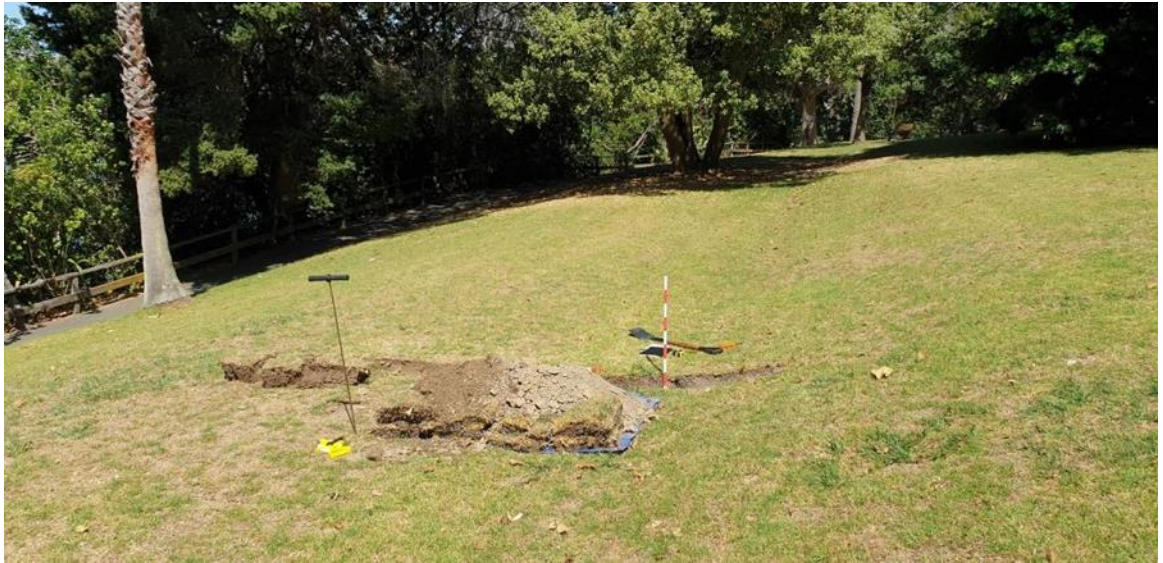
**Figure 50. View looking south-east over the old road/track alignment showing the location of the test trench**

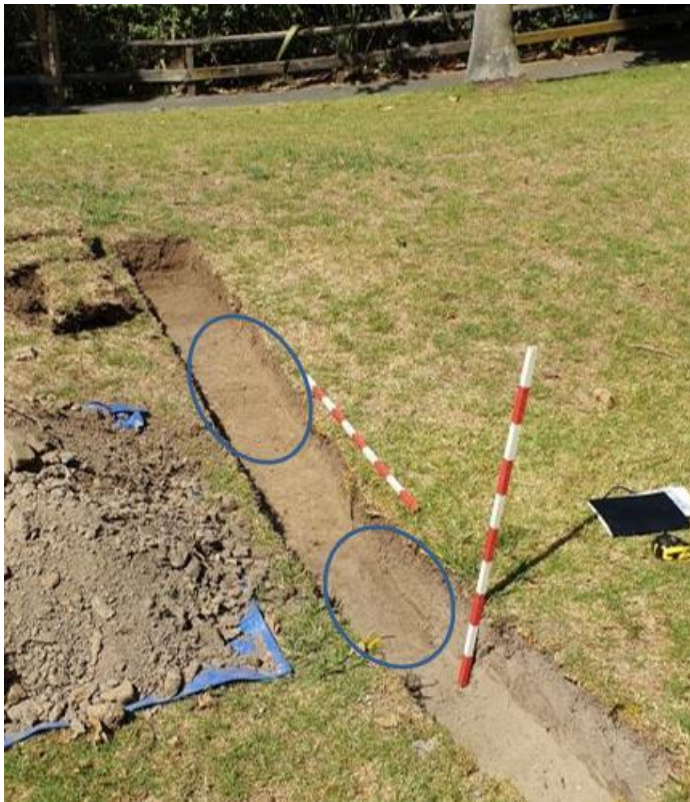
A test trench excavated across the lower of the two terrace-like features exposed a former road/track surface beneath 10-25cm of mixed pale grey silty clay (the depth of the fill overburden increased towards the back scarp). The road/track surface measured 2.95m wide and comprised a compacted clay with patches of coal ash waste material deposited along both the inner and outer edge.<sup>1</sup> The depth of the road/track surface appeared to be c.5cm. At some point in time the road/track surface was covered with the excavated fill material and grassed. See Figure 50–Figure 52.

**Figure 51. View looking east over Trench 3 showing the old road/track surface. Patches of coal ash waste are circled**

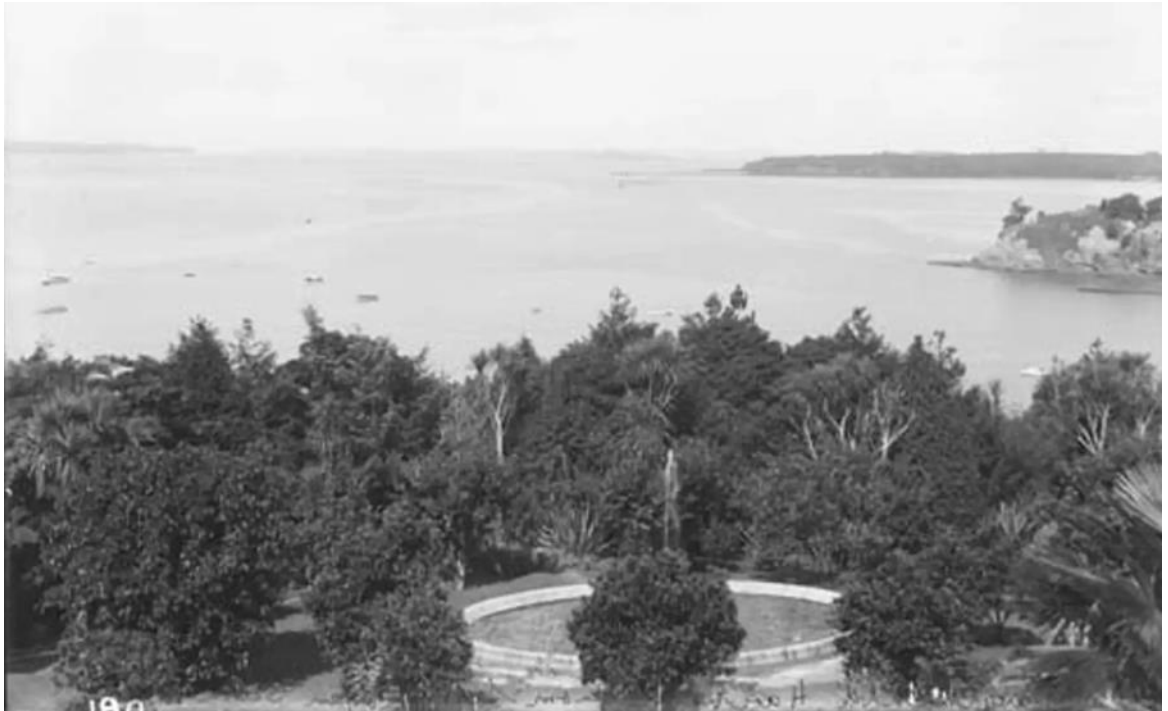
The road/track is unlikely to be associated with John Logan Campbell's residence on the property as this area appears to be largely covered in trees in photographs taken during his occupancy (Figure 56) and the survey plan of the property produced in 1916 does not show a track in this location (Figure 57). Of interest also is a 1940 aerial photograph (Figure 58) which clearly shows the original footprint of Kilbryde as well as the alignments of the tracks and driveway. No road/track alignment can be seen in the location under discussion.

**Figure 56.** Circa 1900 photograph taken by Arthur Ninnis Breckon entitled 'Kilbryde. Looking east over garden'. Source: Auckland Museum ref. PH-NEG-A81

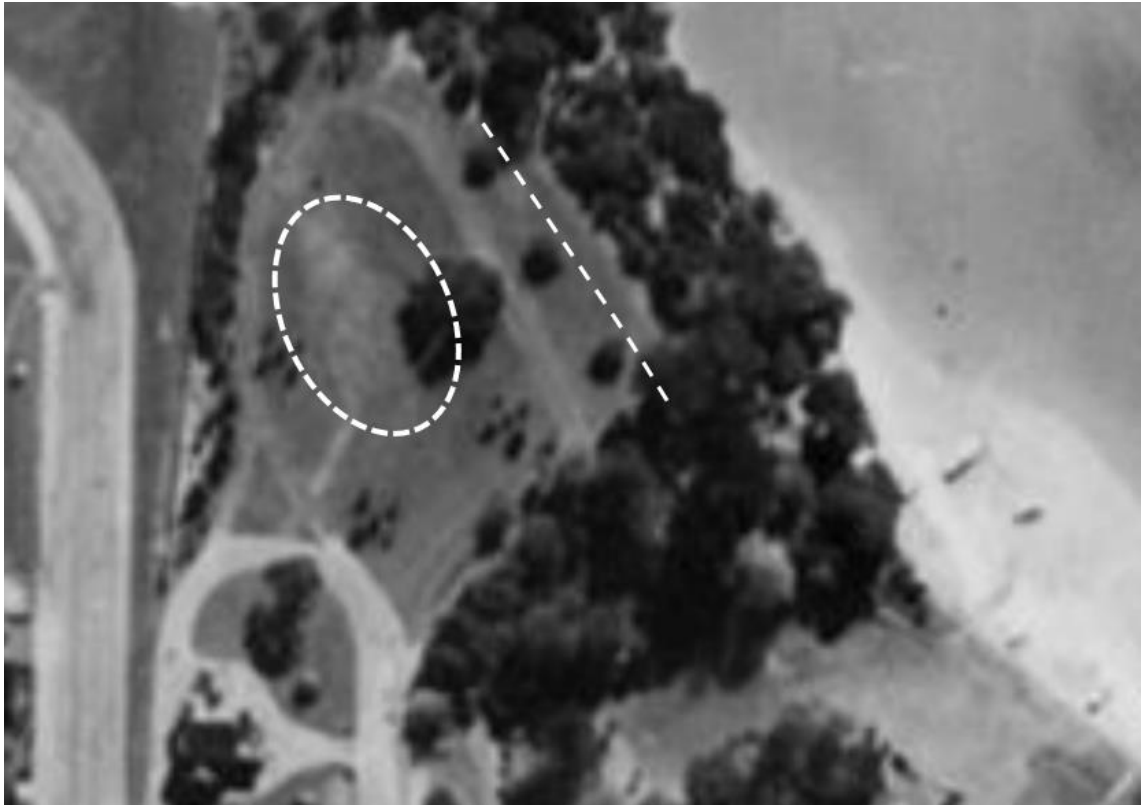
**Figure 58. 1940 aerial photograph where the footprint of Kilbryde is still visible (circled) as are the original path and driveway alignments. Note that there is no clear evidence of a road alignment within the subject area as previously discussed (shown with white line)**

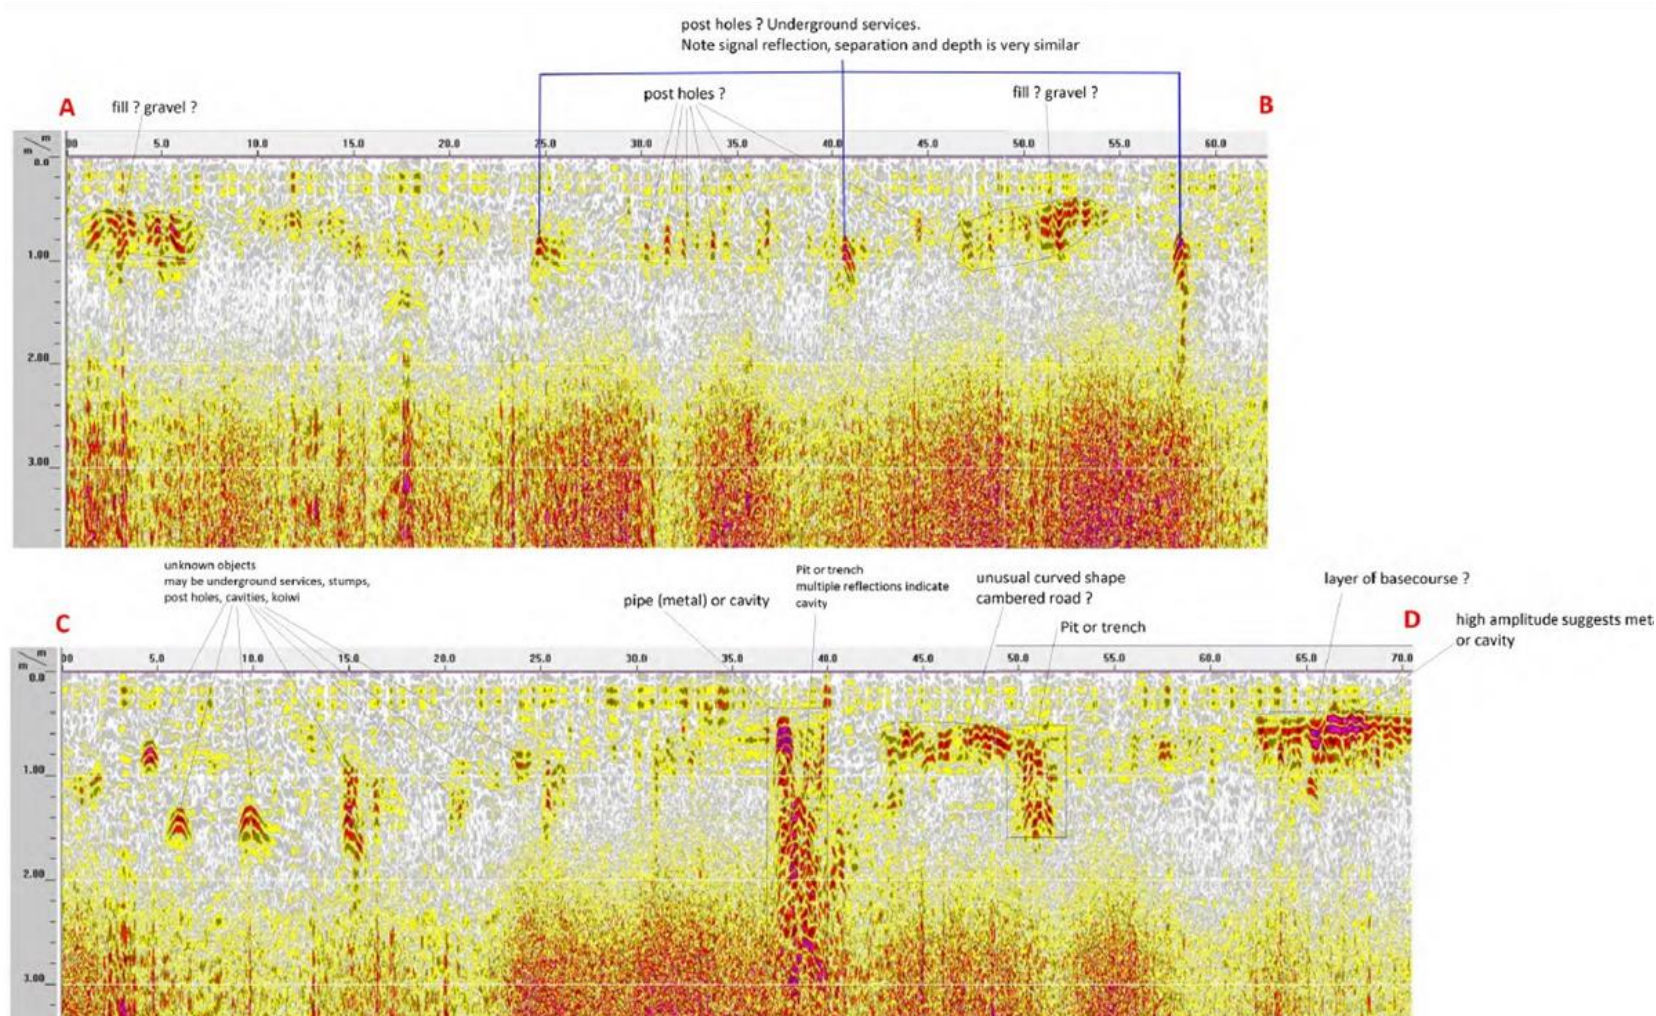
The subsequent 2D-GPR transects (Figure 61–Figure 63) clearly show features within this area that appear to be quite regular and are potentially foundation remains of the house. A possible driveway or road surface and pathway were also identified within this area (Figure 62, Figure 63). Of particular interest, though, is that there is an absence of GPR anomalies between the ground surface to c.0.5m in depth (Figure 62, Figure 63). The layer from the surface to c.0.5m shows evidence of clearance and compaction with heavy machinery (Watson, pers. comm. 2020) that almost certainly occurred during the demolition of Kilbryde and subsequent landscaping of the Park.

Figure 62. 2D GPR survey results along the proposed haul road access and immediate surrounds. Source: Watson 2019
