# **PROPOSED EREBUS MEMORIAL, DOVE MYER ROBINSON PARK, PARNELL, AUCKLAND: ARCHAEOLOGICAL ASSESSMENT OF EFFECTS**

Prepared for Ministry for Culture and Heritage and The Building Intelligence Group

July 2020 (updated from December 2019)

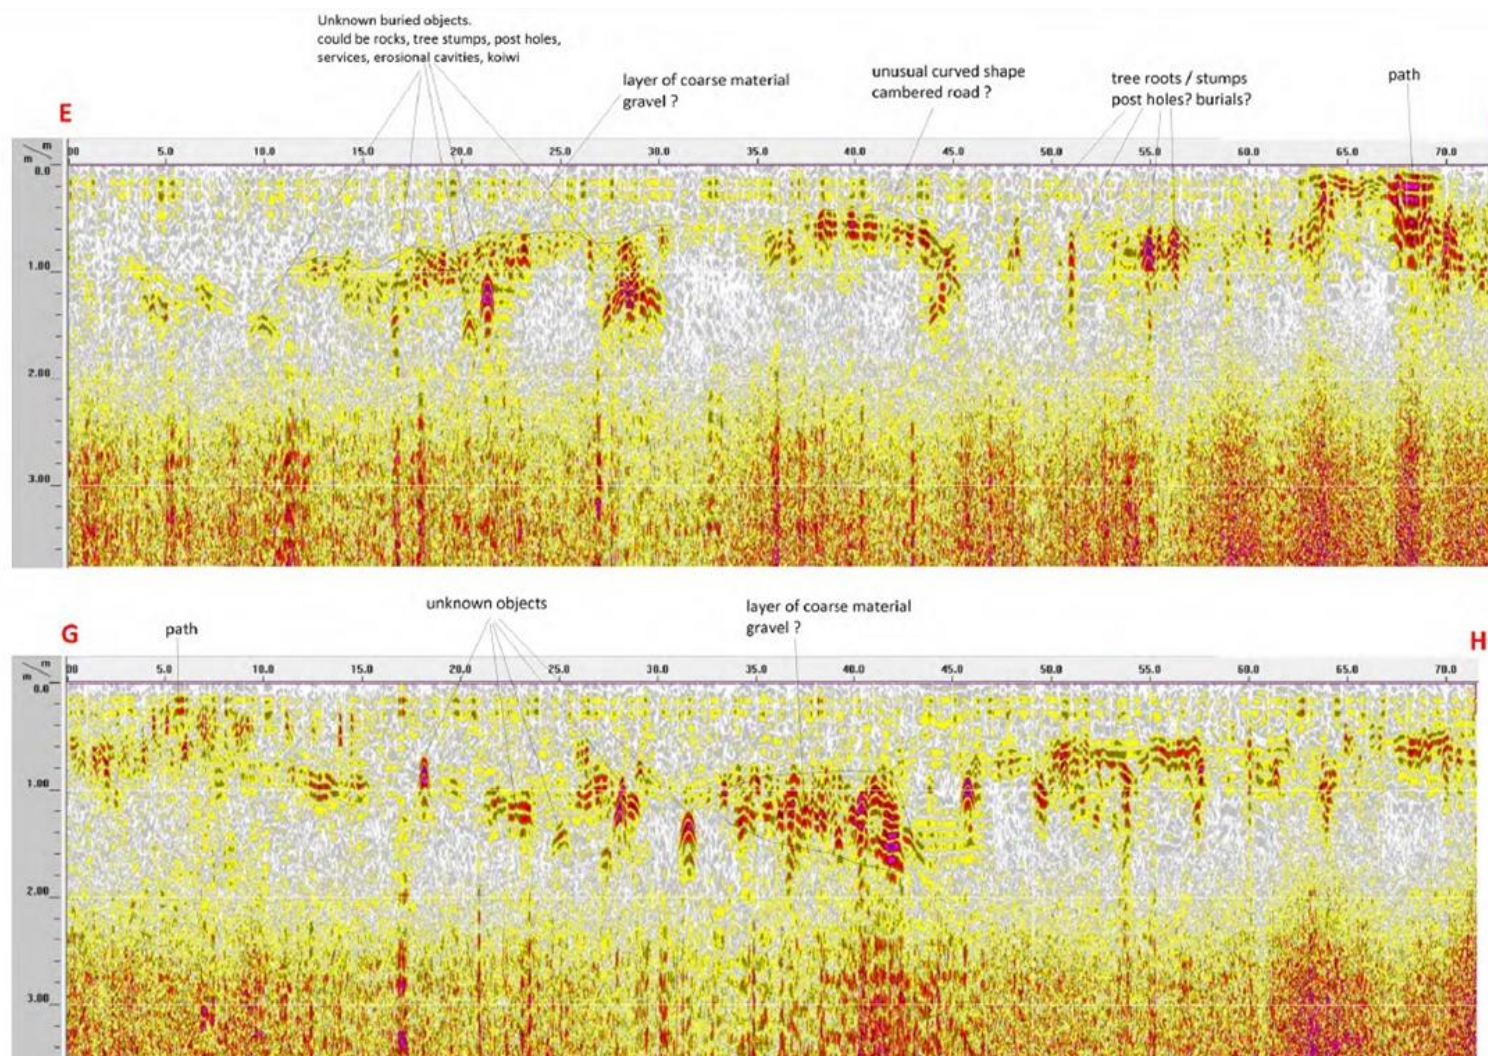
The subsequent 2D-GPR transects (Figure 61–Figure 63) clearly show features within this area that appear to be quite regular and are potentially foundation remains of the house. A possible driveway or road surface and pathway were also identified within this area (Figure 62, Figure 63). Of particular interest, though, is that there is an absence of GPR anomalies between the ground surface to c.0.5m in depth (Figure 62, Figure 63). The layer from the surface to c.0.5m shows evidence of clearance and compaction with heavy machinery (Watson, pers. comm. 2020) that almost certainly occurred during the demolition of Kilbryde and subsequent landscaping of the Park.

Figure 63. 2D GPR survey results along the proposed haul road access and immediate surrounds. The modern path alignment is evident at the western end of transect E-F. Source: Watson 2019

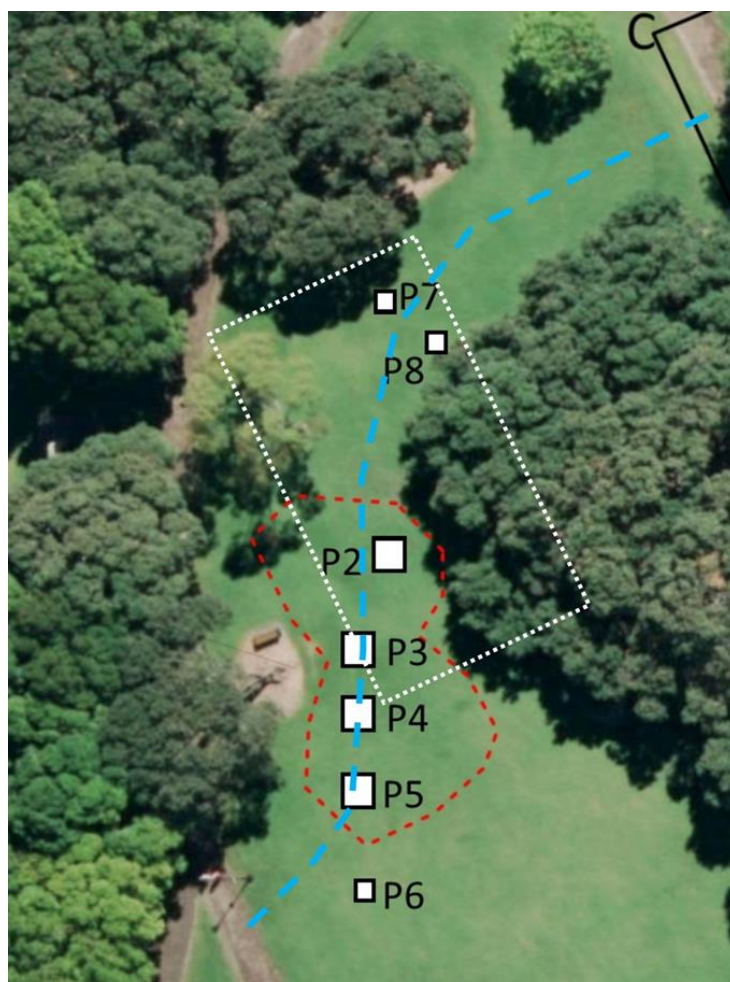
**Figure 64. Aerial showing the locations of test pits 2-8 excavated along the route of the proposed haul road in relation to the area identified through magnetometer survey as possible remains of the former Kilbryde House (outlined in red); the location of Kilbryde as determined through historic plans and aerials (outlined in white) and the proposed haul road alignment (shown in blue). Aerial source: Auckland Council Geomaps 2020**

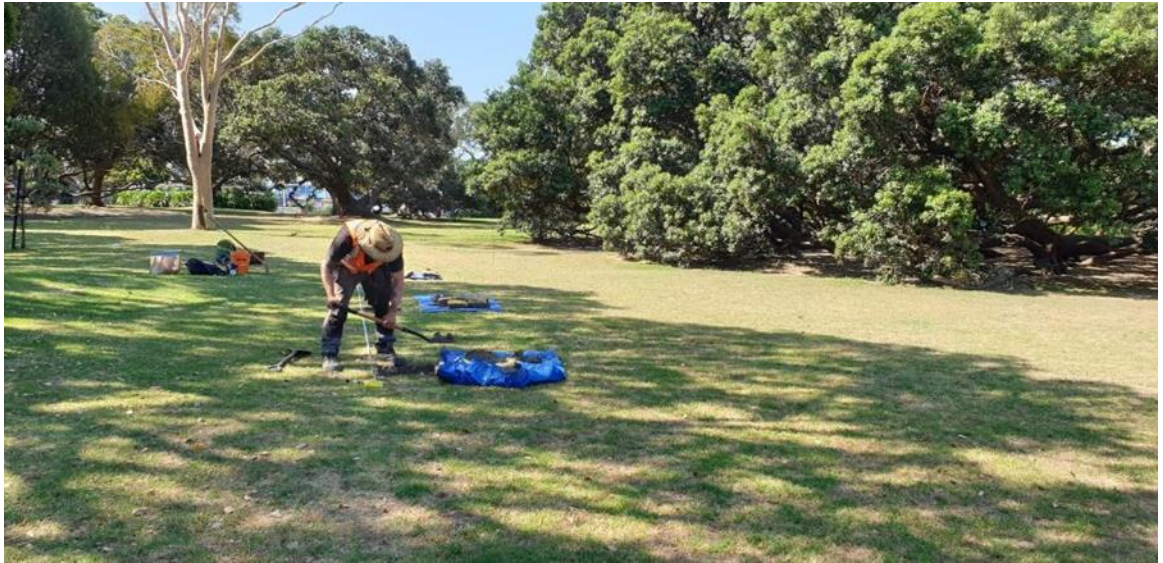
**Figure 65. Excavation of test pits along the proposed haul road alignment**

Test excavations were also undertaken within the previously identified extent of Kilbryde House where the temporary haul road is proposed to run. These excavations were undertaken both in the area identified within the geophysical survey as most likely being the location of the house (due to the density and regularity of anomalies interpreted as likely foundation remains) and within the area identified through historic research as being the location of the house (slightly to the north, but overlapping with the area identified during geophysical survey – see Figure 68). The test excavations identified a densely compacted layer of pale grey mixed silty clay down to at least 35cm below the existing ground surface. GPR survey identified this layer to a depth of c.50cm with no anomalies present until this depth.

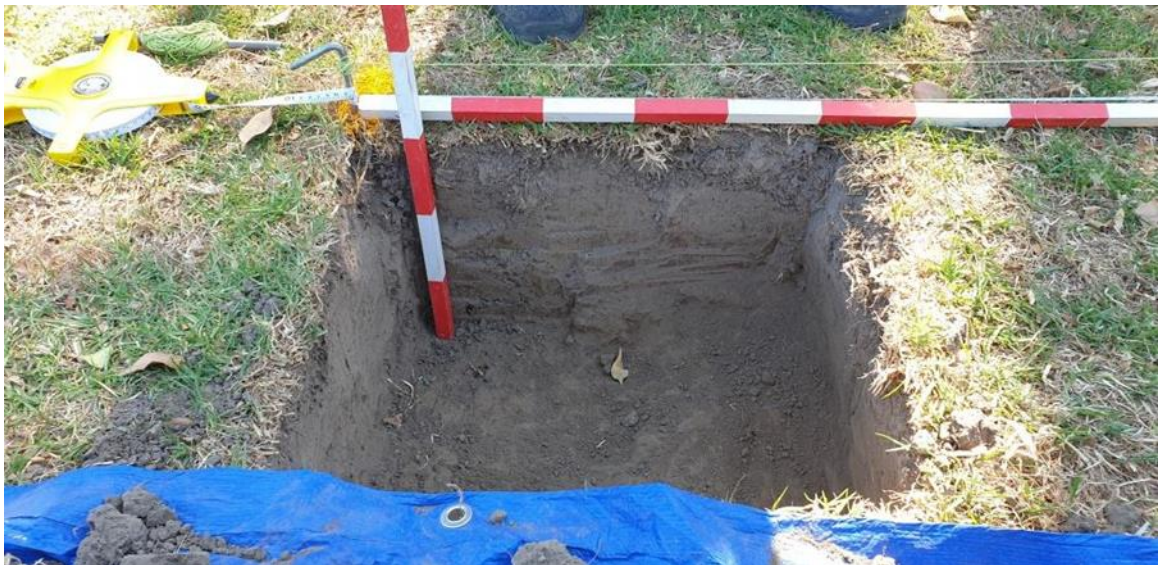
**Figure 66. Test pit 2 profile – showing the typical results of test pitting along the proposed haul road alignment and within the footprint of Kilbryde**

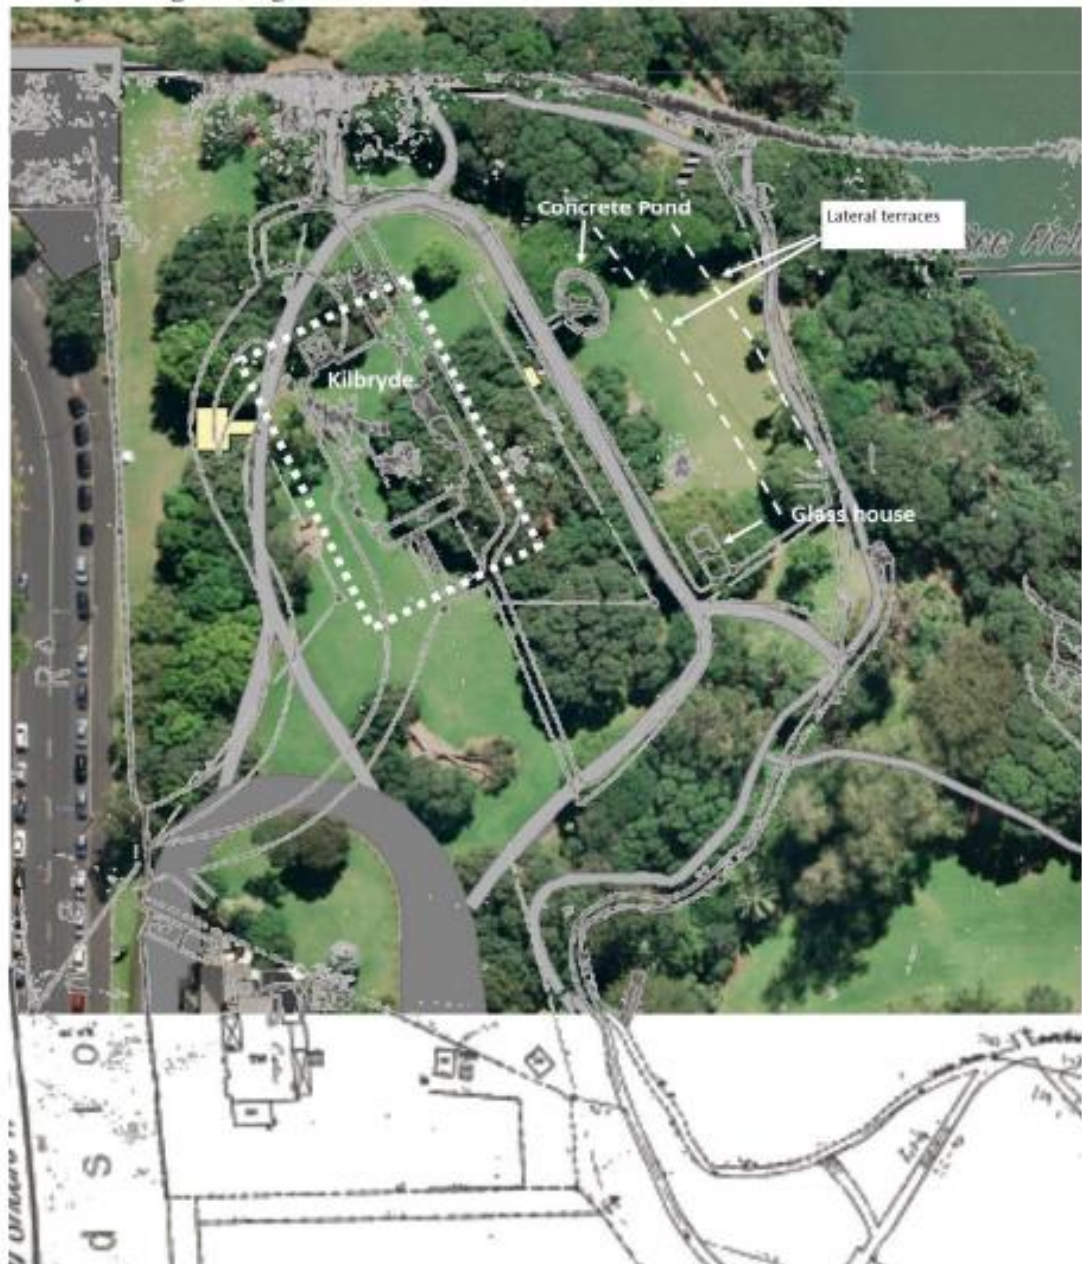
Detail of Parnell Field Sheet No. 34, sheet 1 (1916) overlaid onto a modern aerial photograph showing existing path alignments which correspond largely with those illustrated on the 1916 plan. The location of historic landscape features are labelled; the approximate alignment of the two lateral terraces are shown in white. Plan source: Auckland Council Archives ref. ACC 015 4058-34a; aerial source: Auckland Council Geomaps 2019

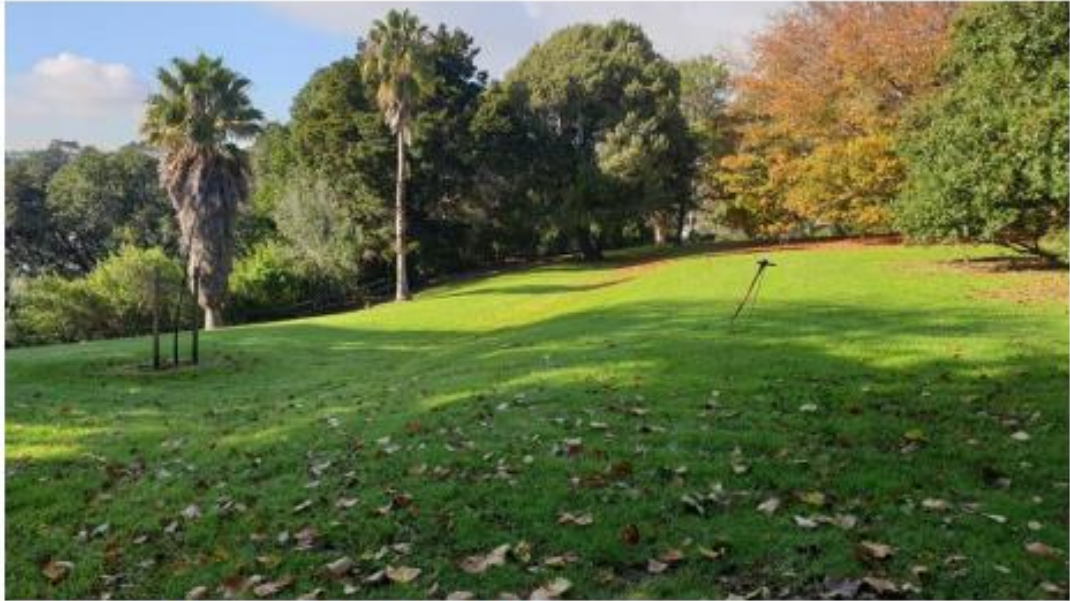
View looking south-east over the broad landscaped terraces

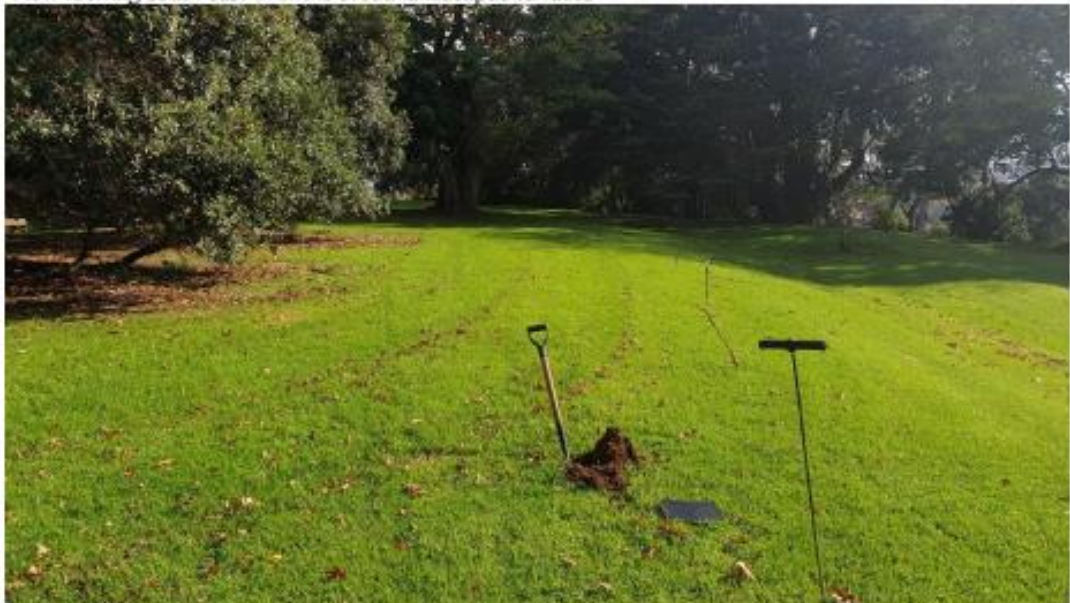
View looking northwest over the terraces

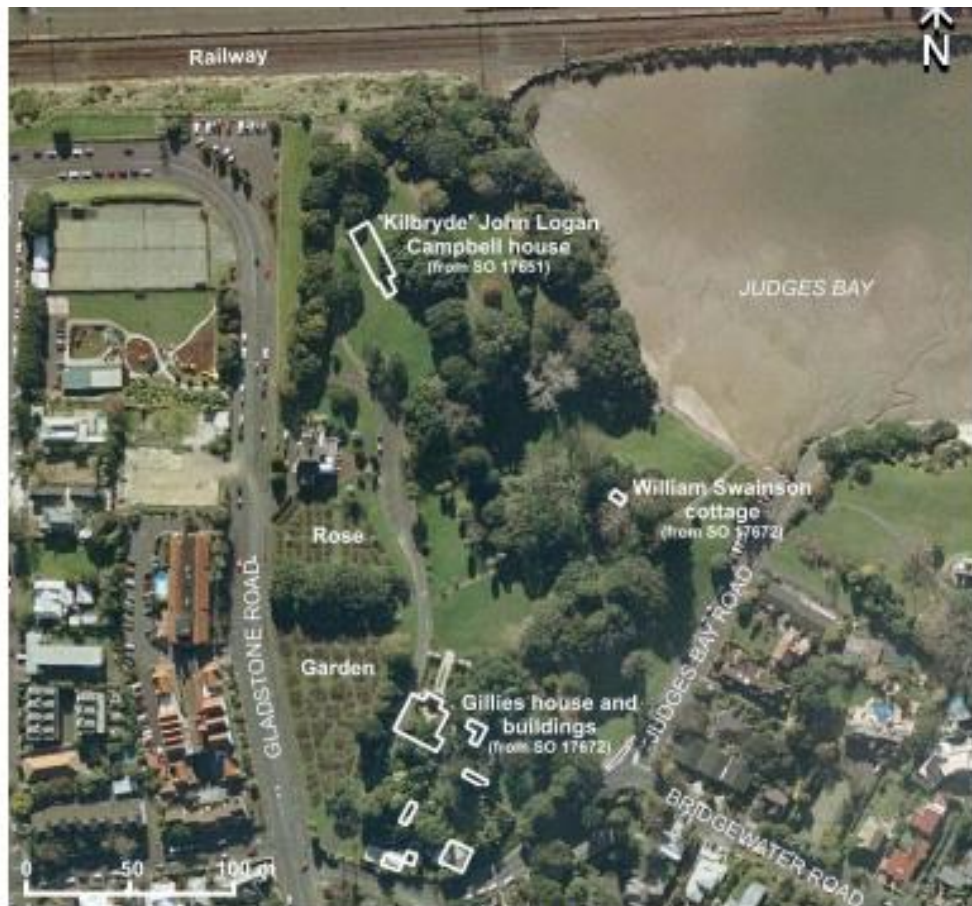
Aerial photograph marked with locations of historic house sites, Dove Meyer Robinson Park, Parnell
